HISTORIC STRUCTURE REPORT

Anna Head School

University of California Berkeley, California

Prepared by Knapp Architects San Francisco, California

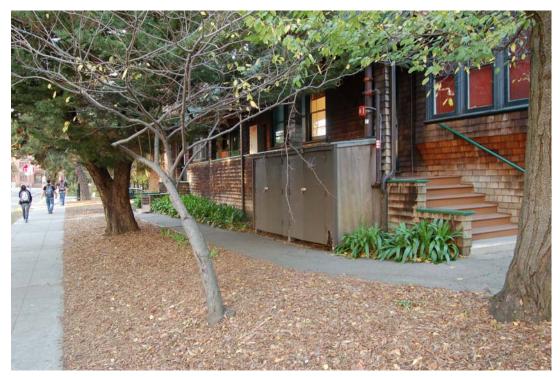
Image 3.1.24. View to south of the narrow strip of land along the east edge of the school property, 2007. There was a sidewalk next to the building in this general location during the period of significance. However, the asphalt paving material was likely added by the university. Denise Bradley photo (0166).

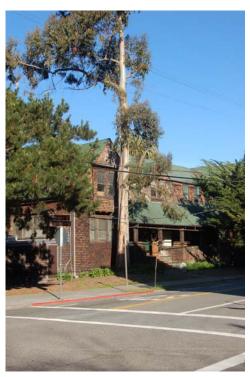
Image 3.1.26. View of the Tasmanian blue gum tree (Tree 68) located on the south side of the entrance (pedestrian) to the Gables (Building B), 2008. The arborist recommended that this tree be regularly inspected since it is located immediately next to the foundation of the building. Denise Bradley photo (0262).
