Adaptive Reuse Study for the

### ANNA HEAD SCHOOL COMPLEX

University of California, Berkeley Project No. 12323A

March 6, 2009

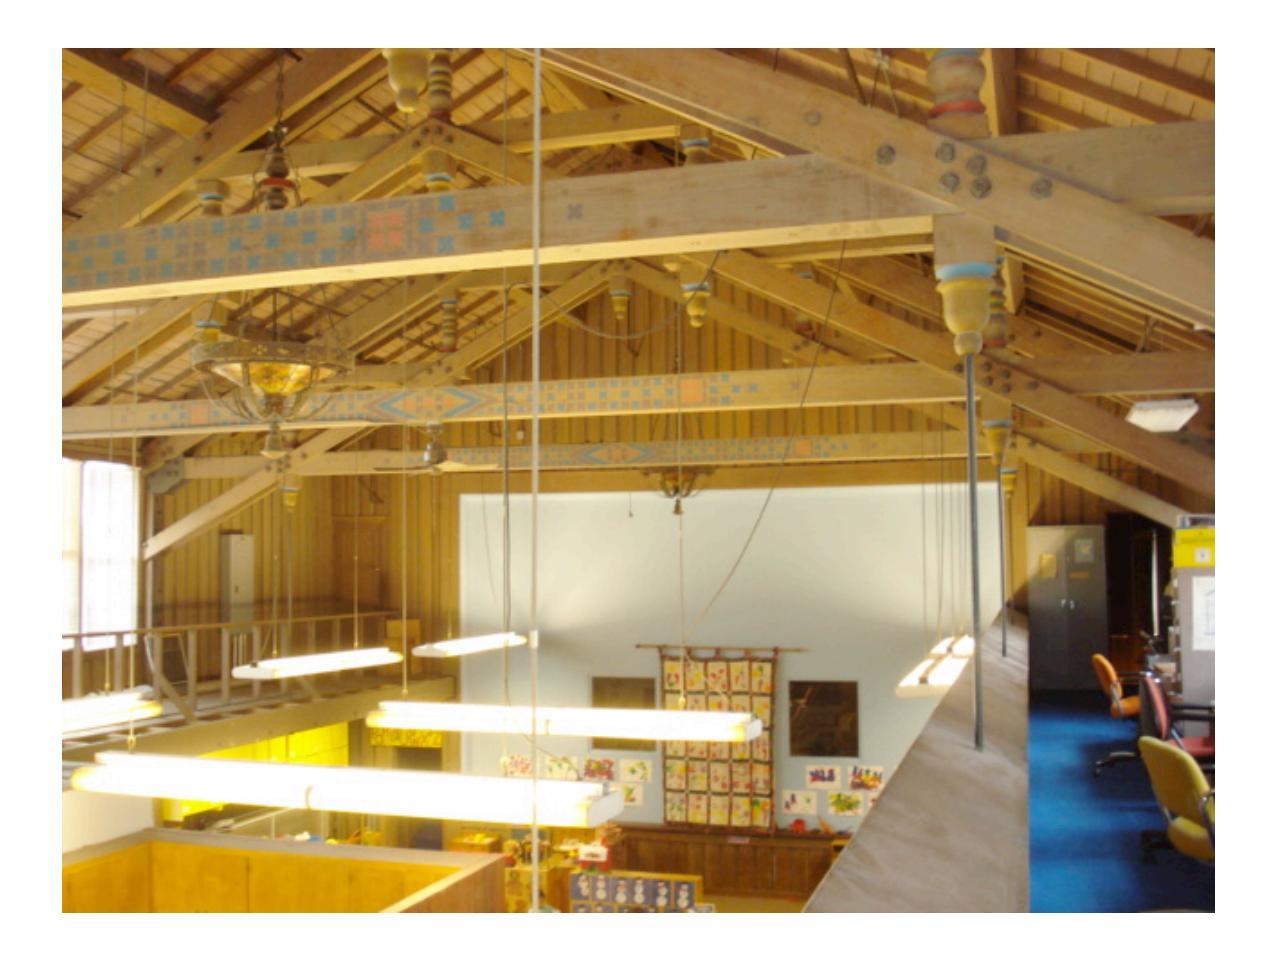
- Foundation: The foundation appears to be concrete in moderate condition. No significant cracking or foundation movement was seen in the limited portions of the foundation that were observed, however further observation of the foundation is recommended in order to verify the condition.

- Shear walls: Seismic retrofit of shear walls is needed. Most particularly, interior shear walls are needed at the east and west ends of the two-story space. These will involve adding sheathing and connections to the existing walls, as well as new foundations underneath. These locations are particularly important because they correspond to vertical offsets in the

roof plane. In addition, shear walls, connections, and foundations should be added at the north and south exterior walls. This would be best done from the building exterior in order to preserve interior wall finishes. See Retrofit Description for typical shear wall construction.

Anchorage to foundation: Anchor bolts and steel plate washers (or retrofit anchor plates) need to be added at approximately four feet on center for the full building perimeter, and at 32 inches on center at shear walls. See Retrofit Description.

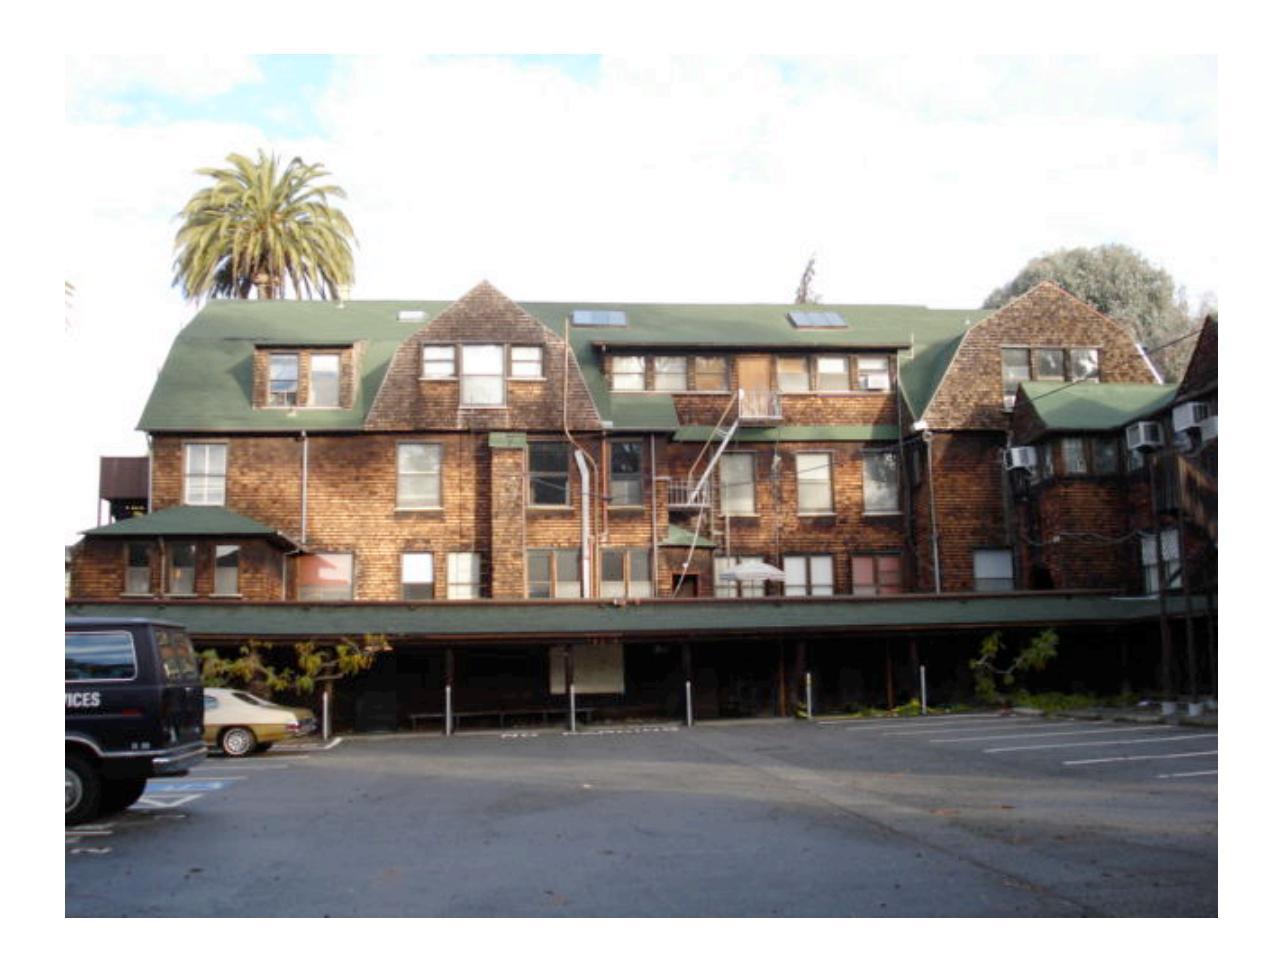
- South wood porch: The south wood porch and the adjacent portion of the arbor (covered walk) appear to be in fair to poor condition due to decay and weathering. Condition should be checked and any decay or other damage repaired.
- North wood entry stairs: The north wood entry stairs and handrails appear to be in fair to poor condition. The foundation appears to be of unreinforced rubble stone masonry that is deteriorated. This set of entry steps should be removed and reconstructed from the foundation up to meet current codes. If the stone chimney is to stay in place, it is suggested that the steps be reconfigured so as to not end at the base of the chimney.

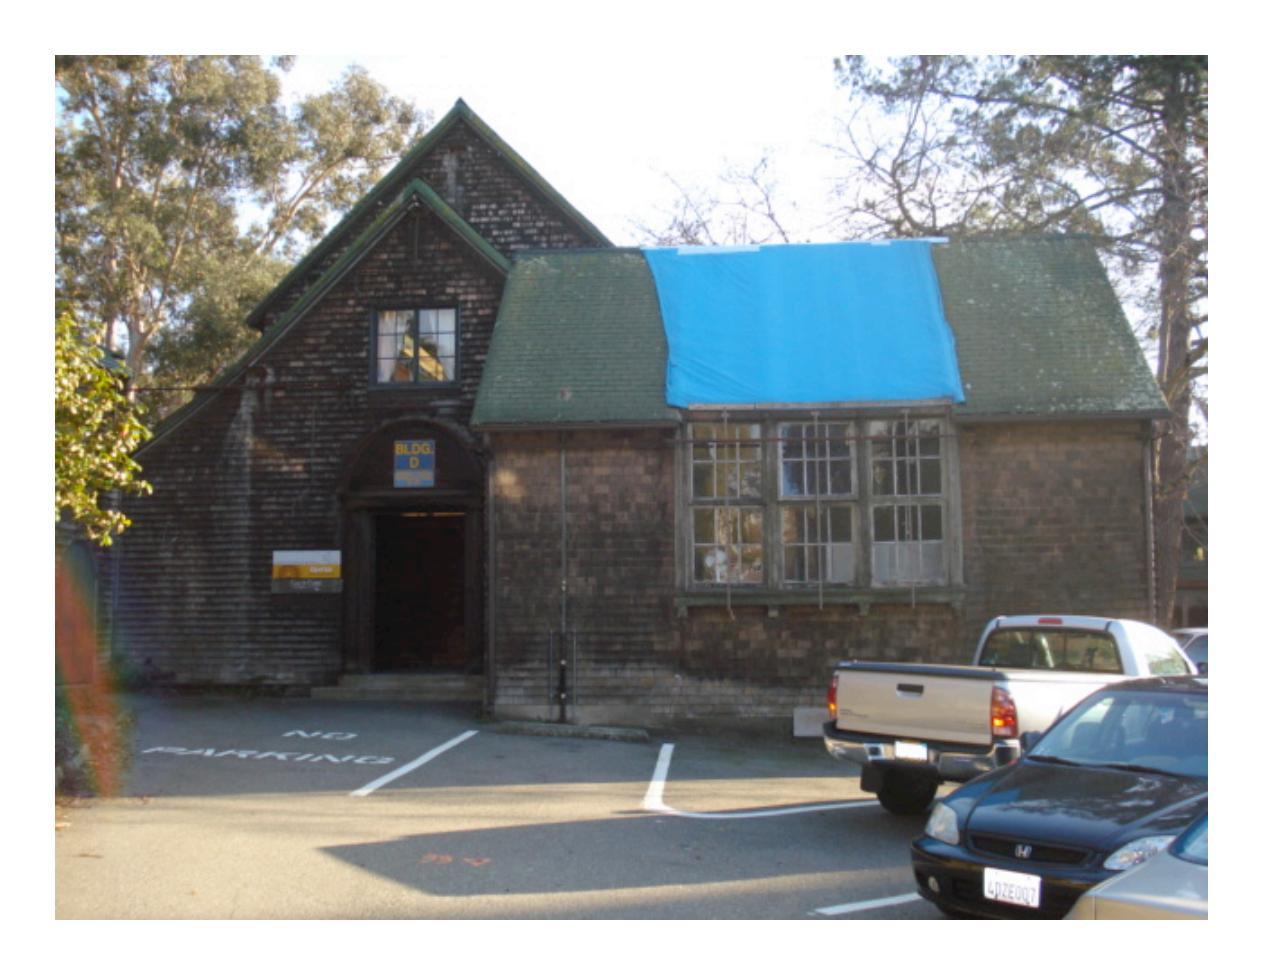
- Anchorage to foundation: Provide anchorage at all existing and new foundation lines as per Retrofit Descriptions
- Single story art studio at north end: Provide plywood sheathing and anchorage to foundation on all existing walls. Evaluate wood framing for possible decay due to water intrusion at the tarp-covered skylight.

<u>Skylight at north end</u>: Provide allowance to reglaze and seal large skylight in one-story "studio" at north end of building.
