Adaptive Reuse Study for the

### ANNA HEAD SCHOOL COMPLEX

University of California, Berkeley Project No. 12323A

March 6, 2009

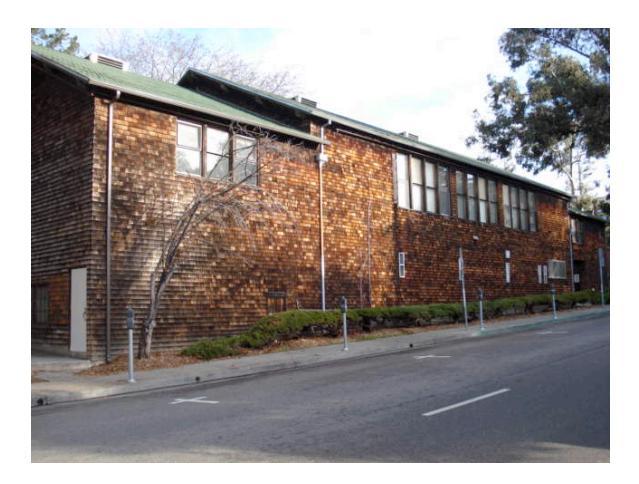
A detailed door and window survey has not been performed as part of this study, but the general conditions of exterior openings have been observed, and most openings will need remedial work. The performance specification for all windows and doors is as follows: Each window and door must operate smoothly, and latch and lock easily. Replace all broken sash chords.

Replace all cracked, broken or missing glass. Replace all cracked, damaged or missing glazing putty. Replica historical glass is NOT required.

Each opening must have a full complement of hardware, including hinges, sash lifts, locks, latches, stops and closers at doors. Hardware that has been added to reinforced the unit over time such as cover plates, corner angles, stitch plates, etc. shall all be removed. All hardware shall be free of paint. Repairs small amounts of dry rot or decay in sashes or doors with epoxy wood consolidant. Use Dutchmen style repairs for larger areas of decay. Where required because unit is damaged beyond salvage and repair, provide a replacement sash or door to match existing

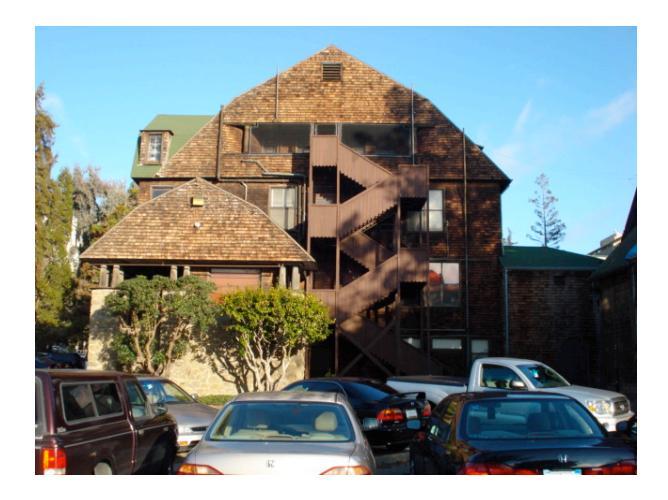
<u>Shingled Siding</u>: Shingle siding is in reasonably serviceable condition. There are selected areas of more pronounced weathering, warping and wear, but in general, the siding is not at the end of its lifespan. Given the age of the building, we assume that the singles are not original.

We've observed the windows and doors are not provided with head flashings, and have been told that water intrusion is a major problem with these buildings. Therefore, there are two possible options to consider for the exterior siding;

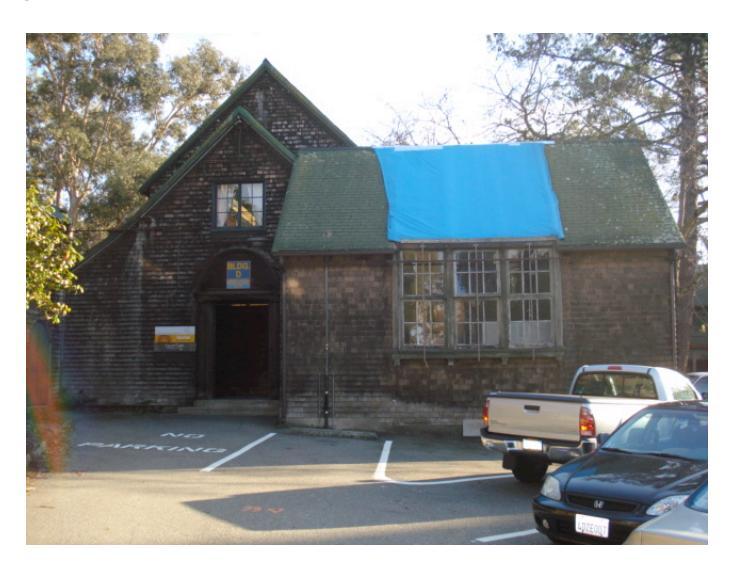
<u>Shingles Siding</u>: Shingle siding is in reasonably serviceable condition. There are selected areas of more pronounced weathering, warping and wear, but in general, the siding is not at the end of its lifespan. Given the age of the building, we assume that the singles are not original.

We've observed the windows and doors are not provided with head flashings, and have been told that water intrusion is a major problem with these buildings. Therefore, there are two possible options to consider for the exterior siding;

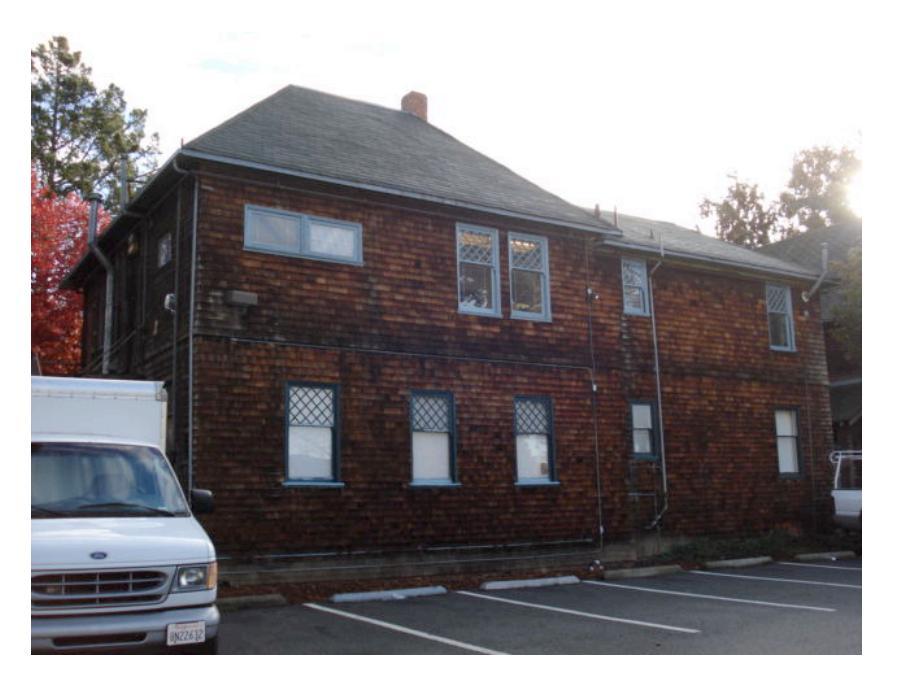
<u>Shingles Siding</u>: Shingle siding is in reasonably serviceable condition. There are selected areas of more pronounced weathering, warping and wear, but in general, the siding is not at the end of its lifespan. Given the age of the building, we assume that the singles are not original.

We've observed the windows and doors are not provided with head flashings, and have been told that water intrusion is a major problem with these buildings. Therefore, there are two possible options to consider for the exterior siding;
