HISTORIC STRUCTURE REPORT

Anna Head School

University of California Berkeley, California

Prepared by Knapp Architects San Francisco, California

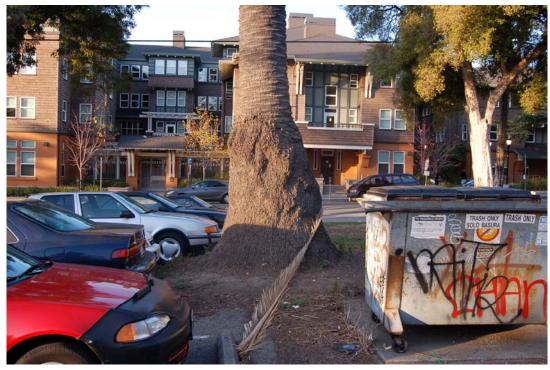
Image 3.1.11. Base of western Canary Island date palm (Tree 41), 2007. Denise Bradley photo (0206).

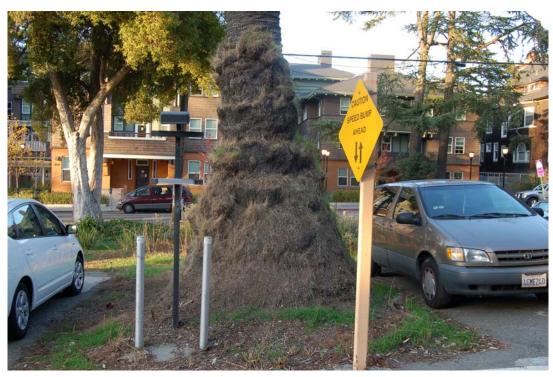
Image 3.1.12. Base of eastern Canary Island date palm (Tree 42), 2007. Denise Bradley photo (0214).

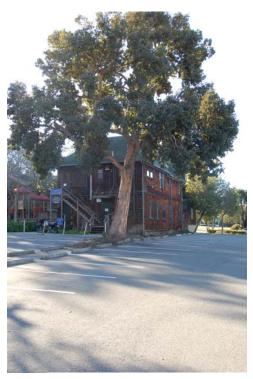
Image 3.1.19. View to southeast of the property line area between Anna Head and 2520 Channing Way. There was a fence along this property line during the period of significance. The red flowering gum (Tree 28) is located to the west of the property line (on the 2520 Channing Way property), 2008. Denise Bradley photo (0222).

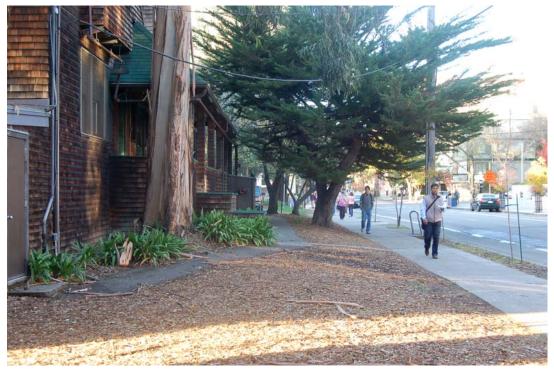
Image 3.1.23. View to the north of the narrow strip of land along the east side of the school property, 2007. During the period of significance there was a hedge and, later, also a fence along the property line. Denise Bradley photo (0169).

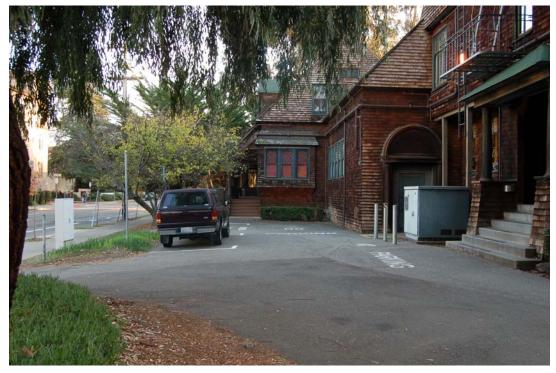
Image 3.1.25. View to south of asphalt-paved area on the east side of the school property, 2007. This area was part of the lawn or garden during the period of significance. Photo also shows the secondary entry (vehicular) on Bowditch Street. Denise Bradley photo (0219.

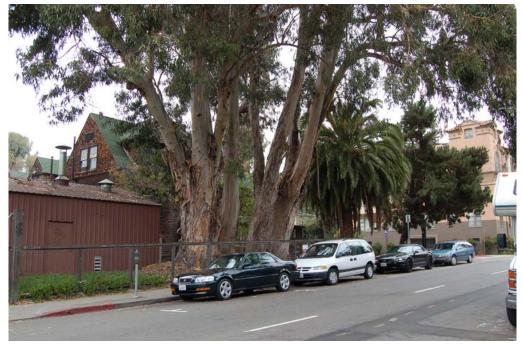
Image 3.1.28. View to northeast of the east end of the south side (Haste Street) of the school property, 2007. The group of *Eucalyptus globulus* trees (Trees 62-65) were present and the Canary Island date palm (Tree 61) may also have been planted before the end of significance. The existing fence is a university-era feature, although there was a fence located along this edge during the Anna Head School-era. Denise Bradley photo (0138).

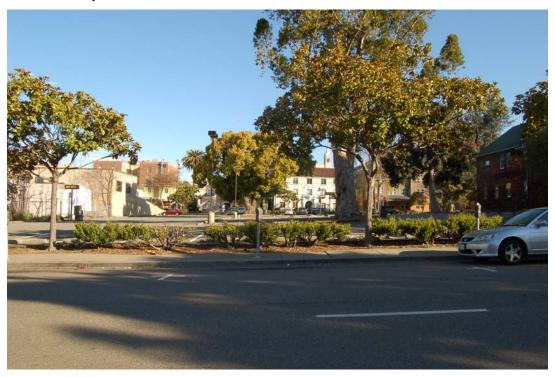
Image 3.2.1. View to the north of the parking lot on 2520 Channing Way, 2008. Before the university purchased this lot (in 1948), there was a house, a green house, trees, lawn, and other vegetation. Denise Bradley photo (0227).

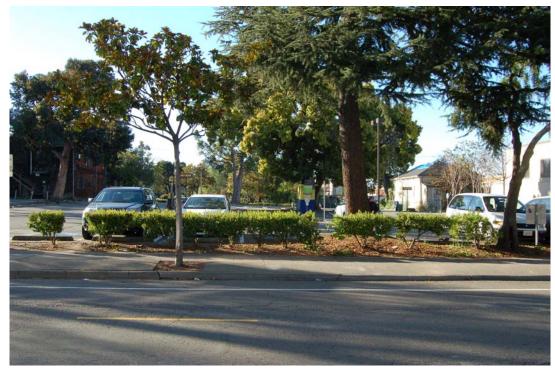
Image 3.2.3. View to the south of the parking lot at 2520 Channing Way, 2008. Before the university purchased this lot (in 1948), there was a house, trees, lawn, and other vegetation. Denise Bradley photo(0220).

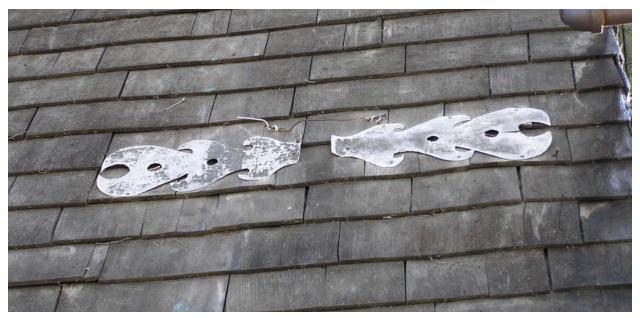
$Image \ 3.4.9. \ Channing \ Hall, (Building \ C), remnant \ of \ metal \ gutter \ leader \ strap, north \ elevation, northwest \ corner, 2008. \ Christopher \ Pollock \ photo.$

Replace all gutters, downspouts and flashings, preferably with copper.
